Project Number: 19-009

Subject: 301 Mission Retrofit Supplemental Monitoring Report 066: Results as of August 9, 2022

Millennium Tower Perimeter Pile Upgrade: Instrumentation Monitoring Data
City and County of San Francisco, California

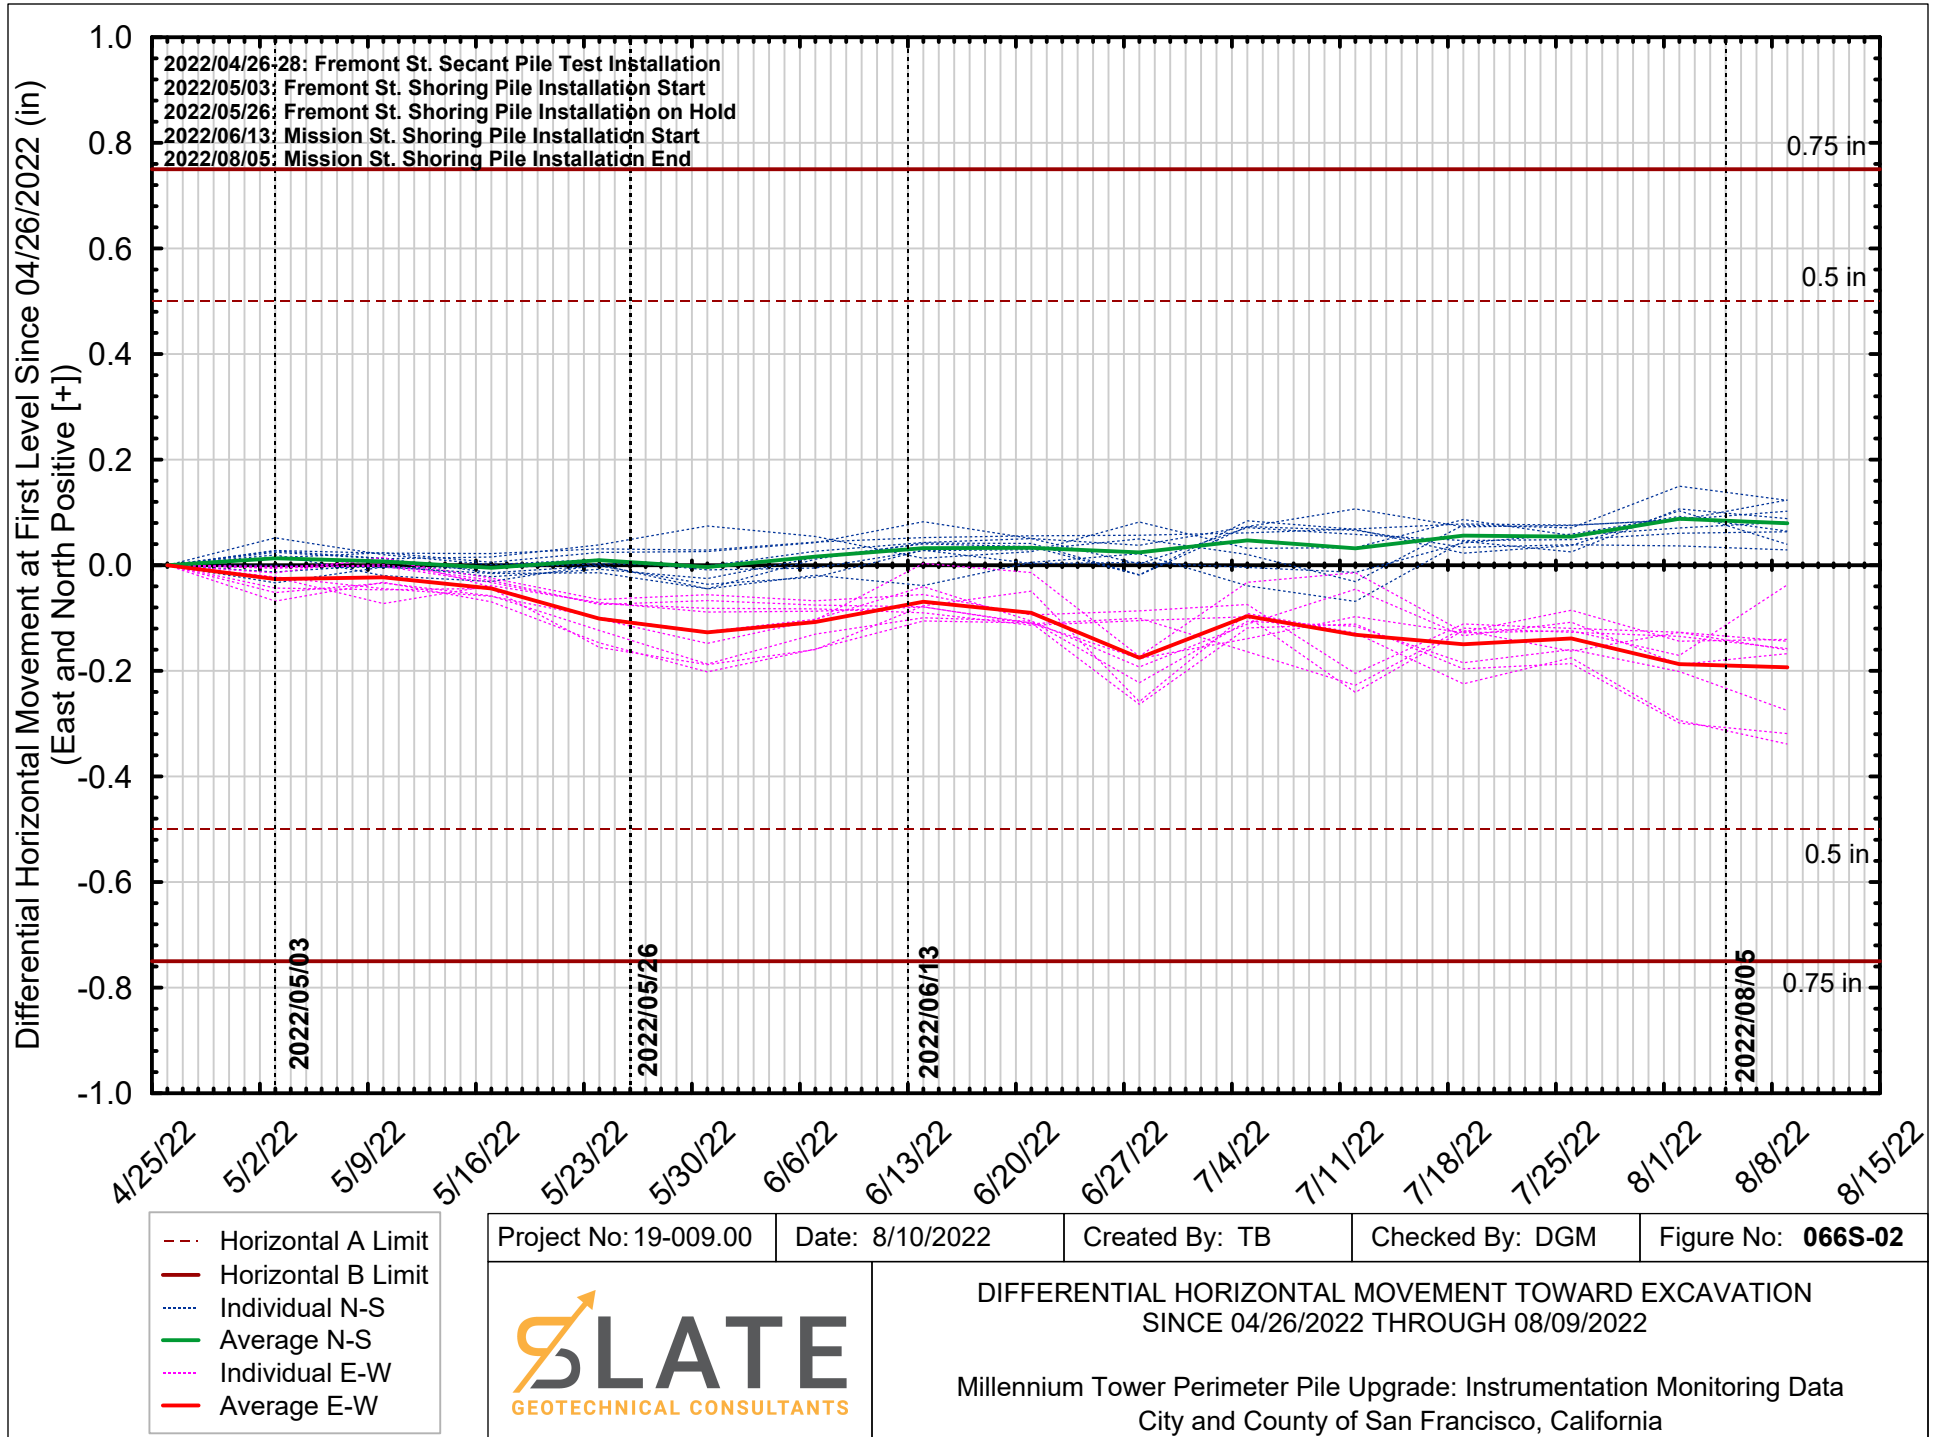
Figure S-02 – Differential Horizontal Movement Toward Excavation Since 04/26/2022 through 08/09/2022

Figure S-02 presents the differential horizontal movement toward the excavation at survey prisms installed at approximately one floor level above grade on the exterior of the building, as well as the average in each of the project north-south and east-west direction, since April 26, 2022, through August 9, 2022. Limits established in the aforementioned letter are included for reference.

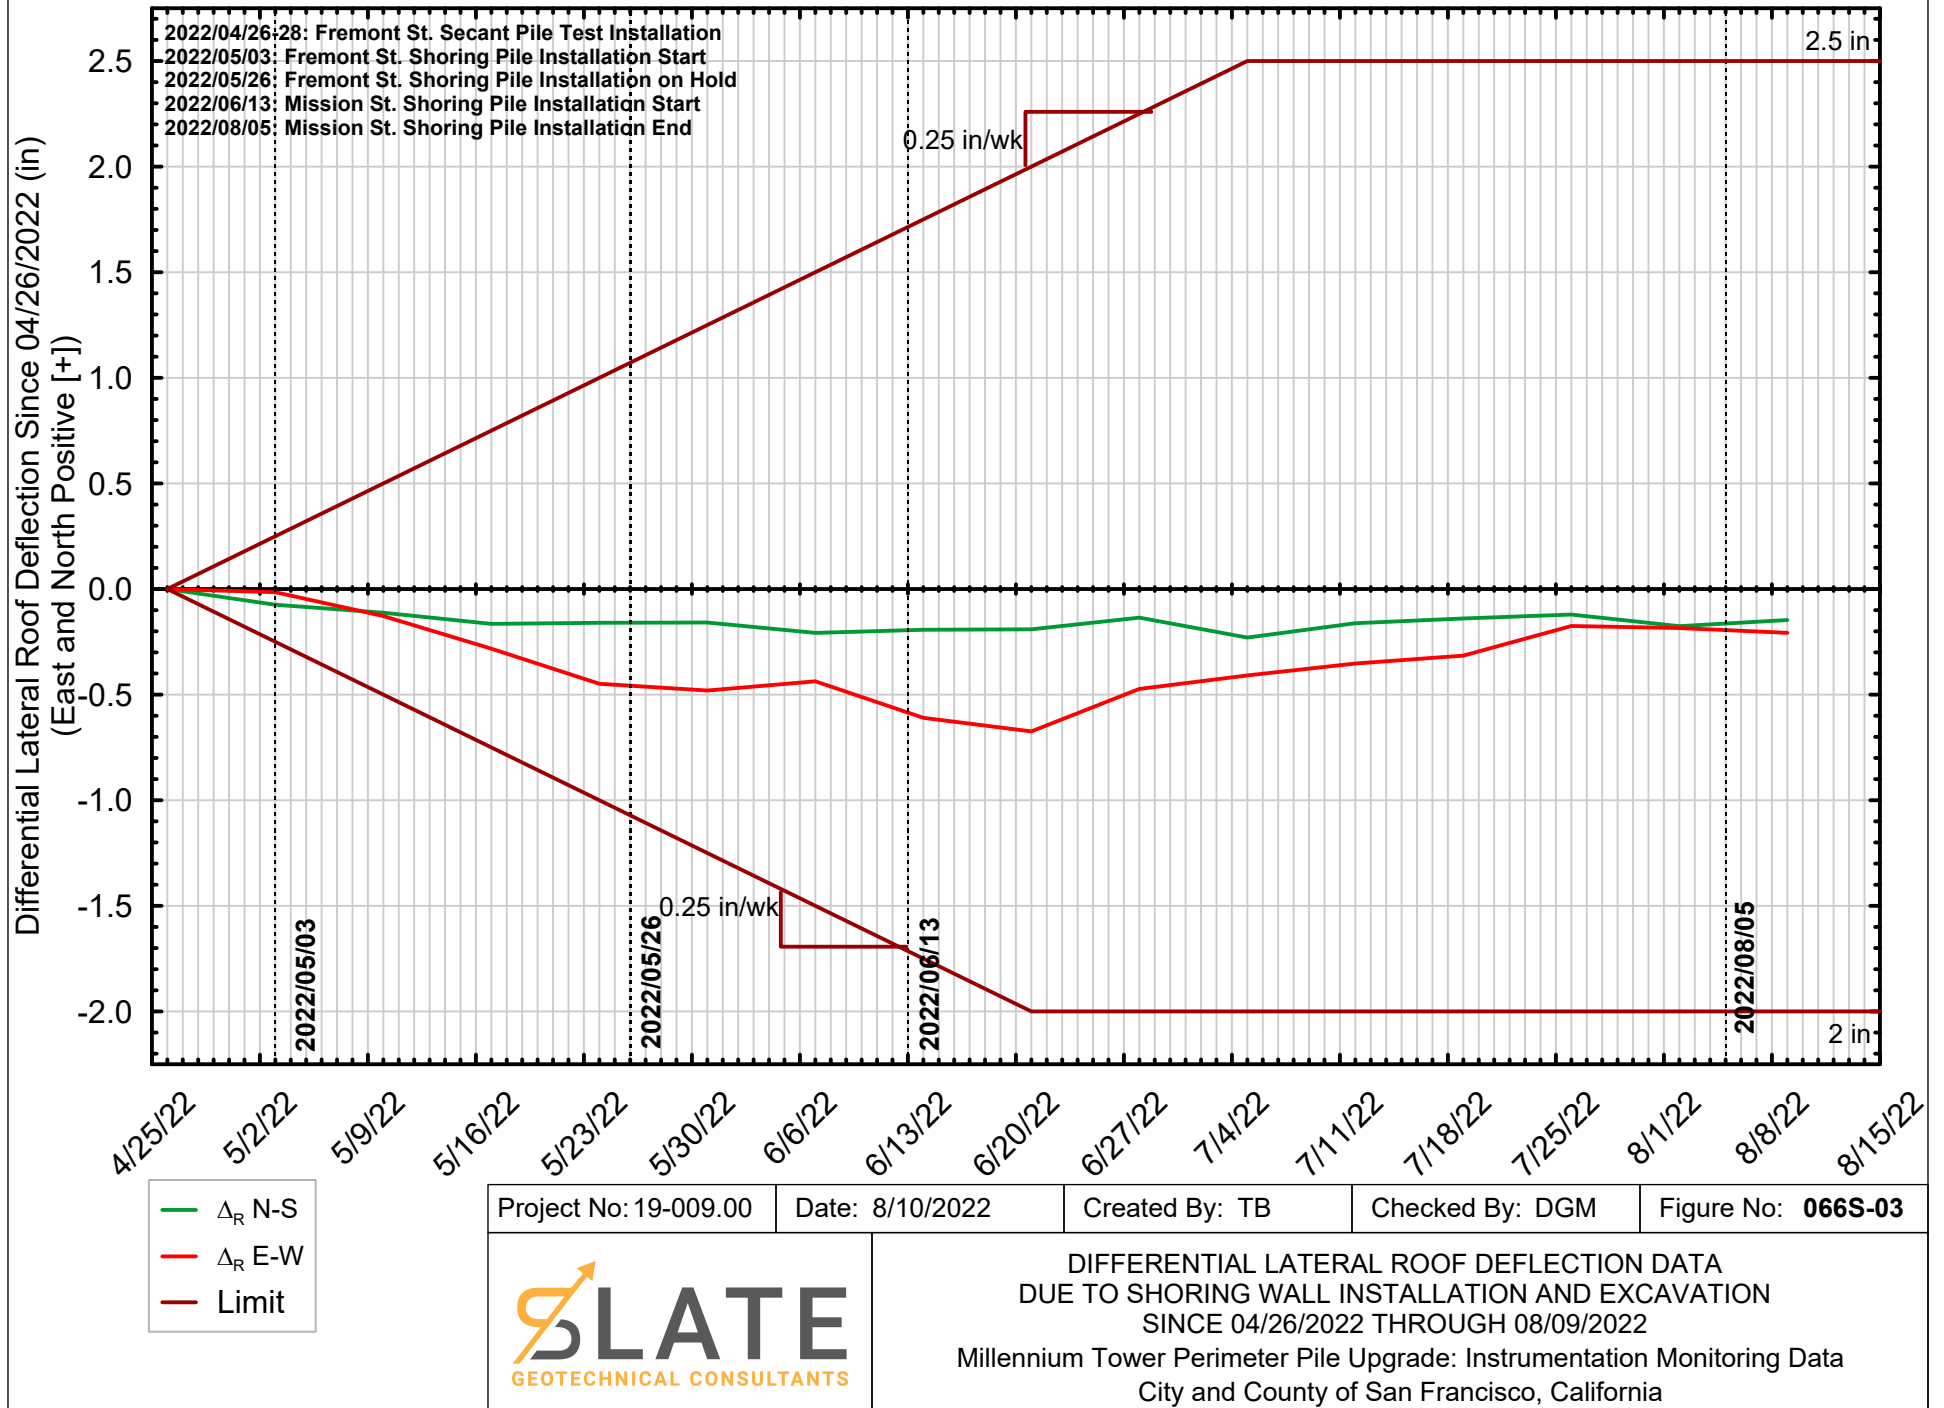
Figure S-03 – Differential Lateral Roof Deflection Data due to Shoring Wall Installation and Excavation since 04/26/2022 through 08/09/2022

Figure S-03 presents differential lateral roof deflection data due to shoring wall installation and excavation since April 26, 2022, through August 9, 2022. Limits established in the aforementioned letter are included for reference. Note that differential lateral roof deflection due to shoring wall installation and excavation is calculated following the aforementioned letter as:

$$\Delta_R = \Delta_{R-prism} - \Delta_H - \alpha T$$

where: Δ_R is the computed differential lateral roof deflection due to shoring wall installation and excavation;
 $\Delta_{R-prism}$ is the differential lateral roof deflection obtained from prism data;
 Δ_H is the average differential horizontal movement "at-grade";
 α is the weekly lateral roof deflection rate (computed as described below); and,
 T is the number of weeks since initiation of shoring wall installation or excavation.

The time frame over which α is computed changes depending on the phase of the work, as specified in the aforementioned letter. For the construction phase during which the shoring wall is installed (currently ongoing), α is computed from the two months of monitoring conducted immediately prior to the shoring wall installation (i.e., monitoring data from February 22, 2022, through April 25, 2022). During the excavation phase (to occur in the future), α will be readjusted to reflect the recorded lateral roof deflection rate in the two months immediately preceding the start of excavation (dates to be determined).

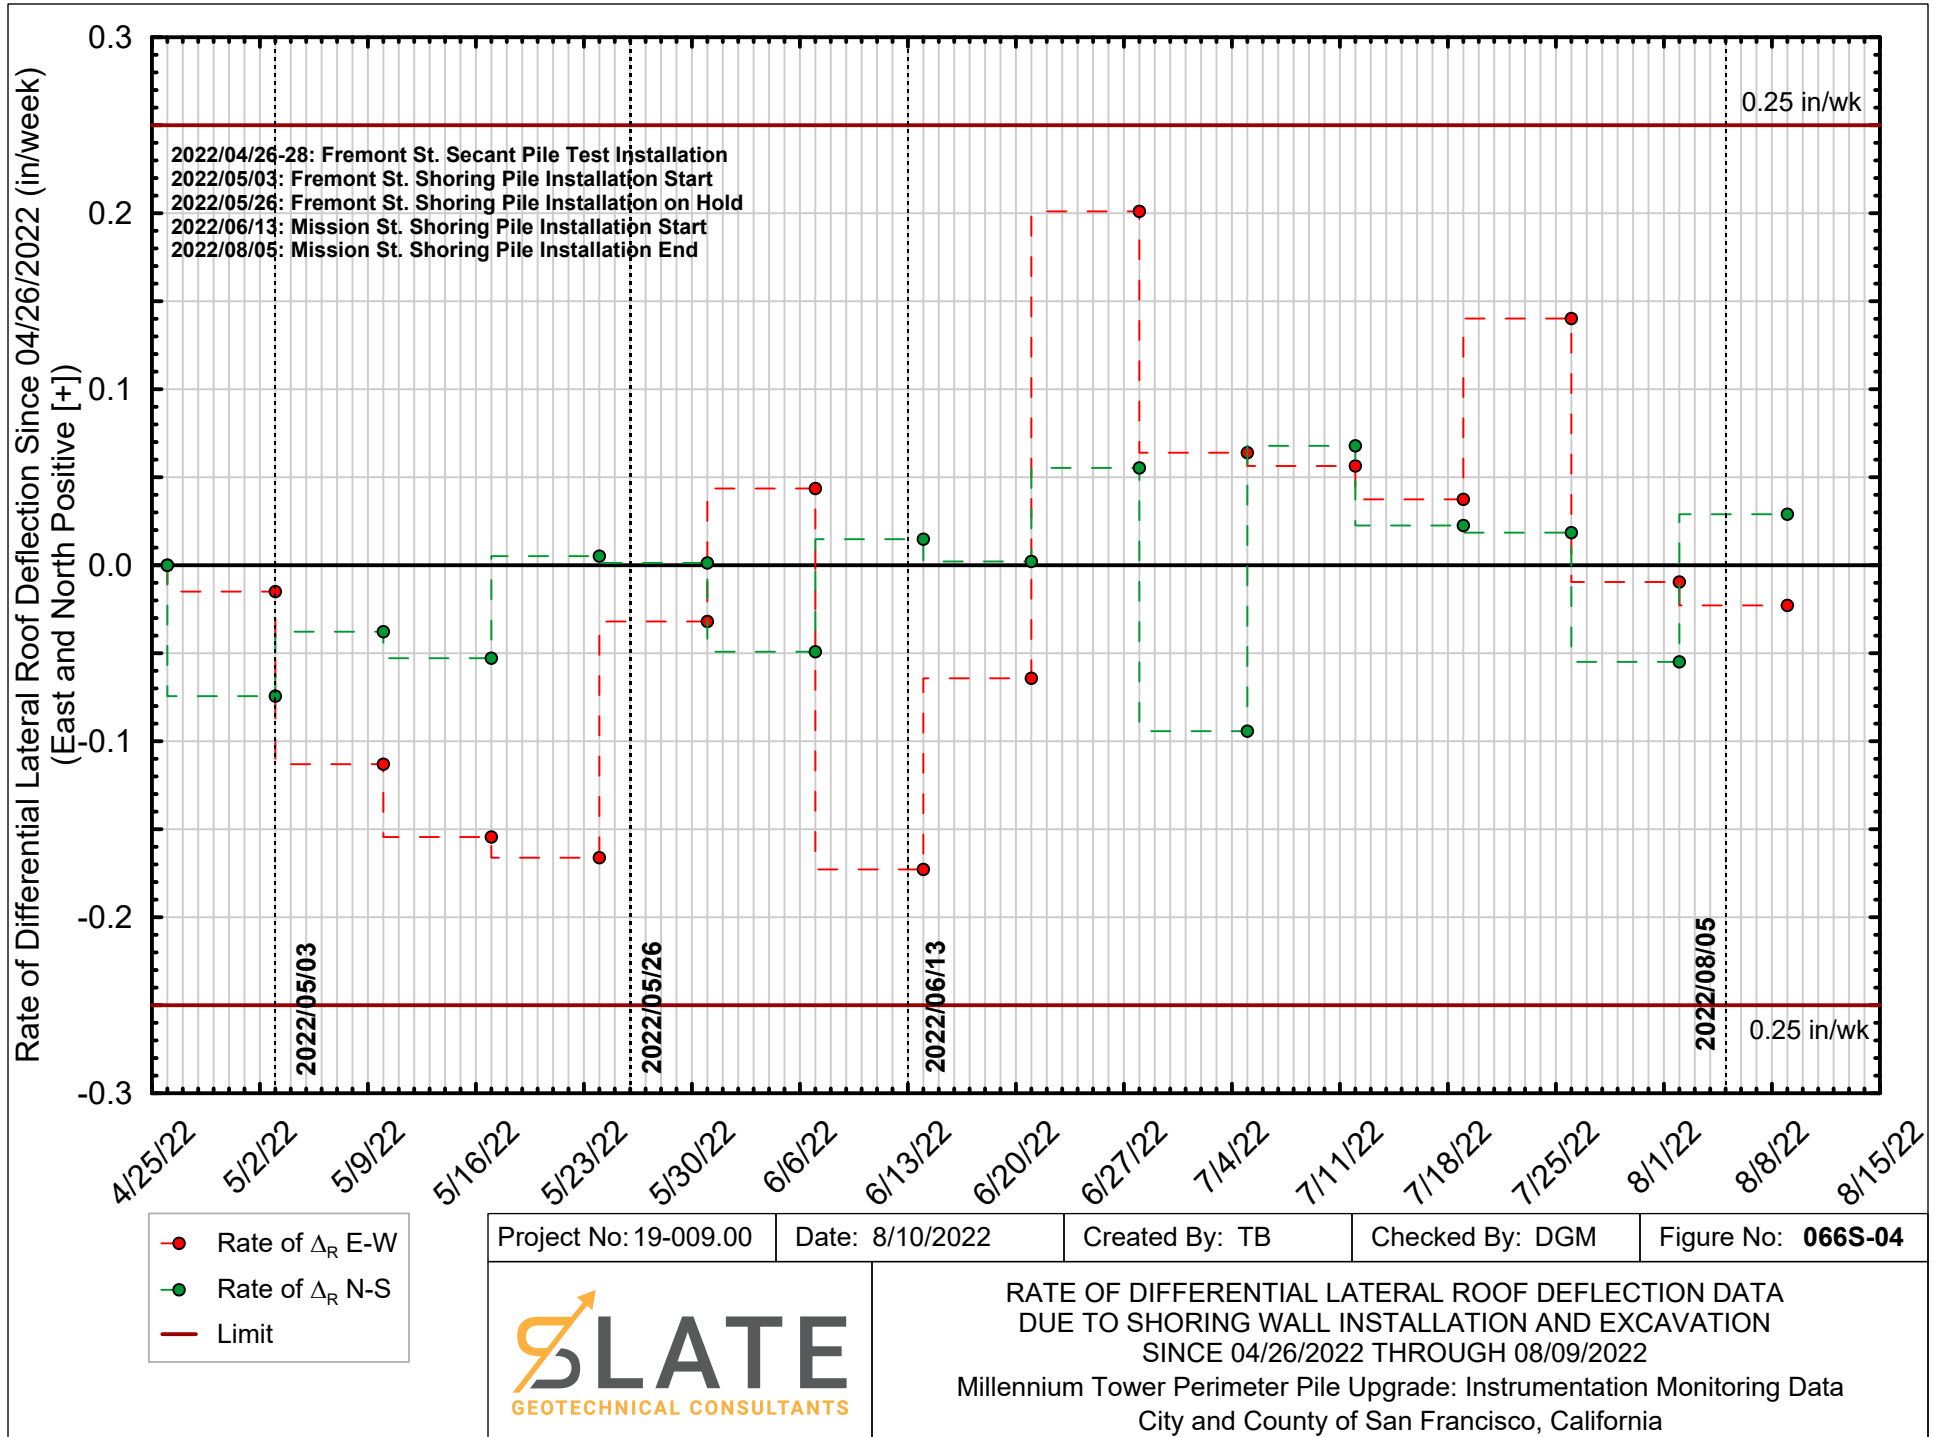
Figure S-04 – Rate of Differential Lateral Roof Deflection Data due to Shoring Wall Installation and Excavation since 04/26/2022 through 08/09/2022

Figure S-04 presents rates of differential lateral roof deflection data due to shoring wall installation and excavation since April 26, 2022, through August 9, 2022. Limits established in the aforementioned letter are included for reference. Note that the rates are calculated as:

$$\frac{d\Delta_R}{dT} \approx \frac{\Delta_{R,t} - \Delta_{R,t-1}}{T_t - T_{t-1}}$$

where: t is an index representing the current instance in time; and
 $t - 1$ is an index representing the previous instance in time.
